Manhole Inspection Summary

Manhole # S17EE2020MH

Location Address: **1800 SOUTH RD**

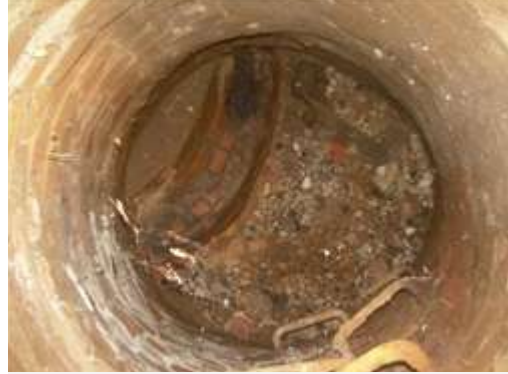
Top View

Corroded steps. Evidence of surcharge - Bench debris. Channel debris.

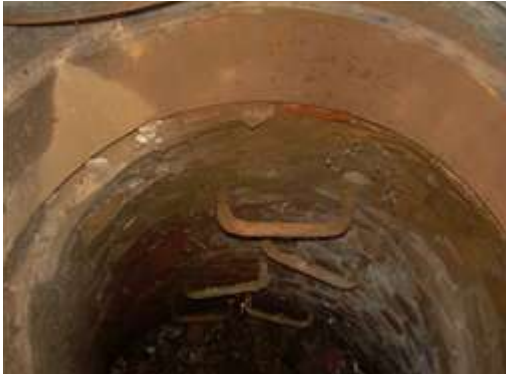
Defect

Frame leaks. Frame offset. Adjustment deterioration and infiltration. Corbel and Barrel infiltration - other side.

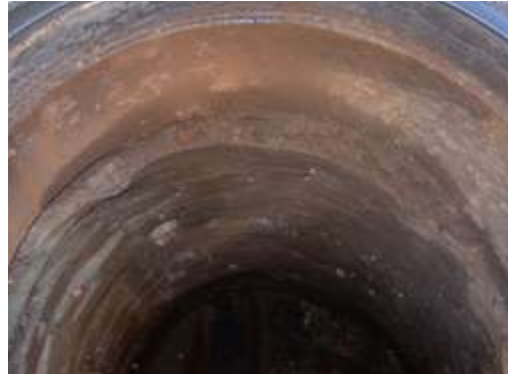
Defect

Frame leaks. Frame offset. Adjustment deterioration and infiltration. Corbel and Barrel infiltration.

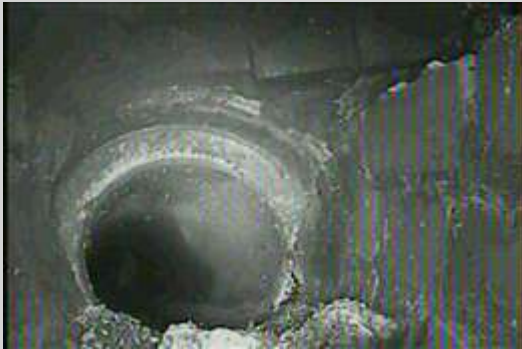
8 in. Circular Gravity Sewer Pipe Out @ 12 O'Clock

Pipe Material: **Unknown** ☐ Pipe Lined

Invert Depth: **8.03** (ft.) Flow Characteristics: **Slow**

Infiltration: **None** Pipe Seal Cond: **Unknown**

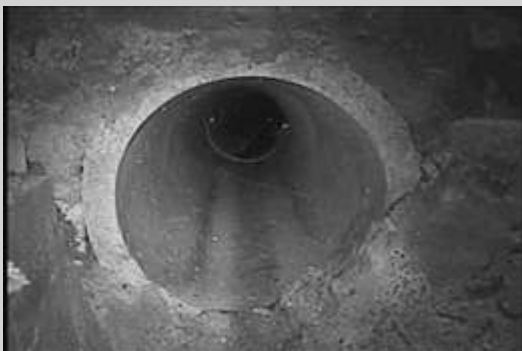
8 in. Circular Gravity Sewer Pipe In @ 9 O'Clock

Pipe Material: **Clay** ☐ Pipe Lined

Invert Depth: **7.43** (ft.) Flow Characteristics: **Slow**

Infiltration: **None** Pipe Seal Cond: **Unknown**
